Manhole Inspection Summary

Manhole # S150__058MH

Insp Date: **3/27/08 9:48 AM**

Location Address: **2680 ST BENEDICT ST**

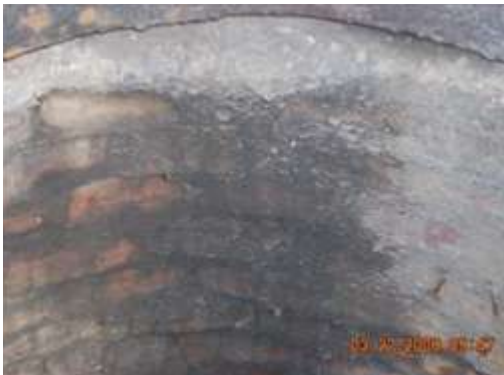
Defect 2

Infiltration: ☐ None ☐ Joint ☐ Cracks ☐ Mortar ☐ Roots ☒ **Wall**

CHIMNEY WALL INFIL.

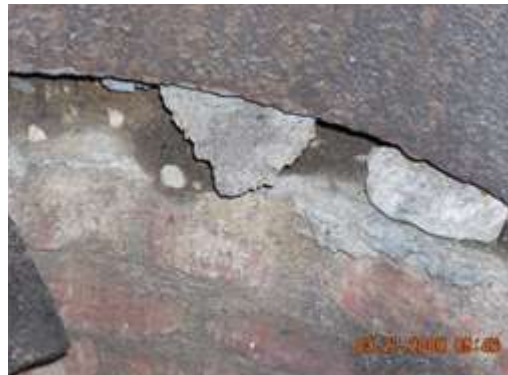
Defect 1

Condition: ☐ Sound ☐ Cracked ☐ Root Intrusion ☒ **Loose Brick** ☒ **Deteriorated**

DETERIORATED CHIMNEY

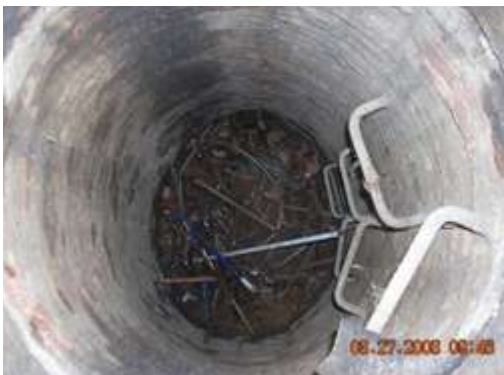
Defect 3

Condition: ☐ Sound ☐ Cracked ☐ Root Intrusion ☐ Deteriorated ☐ Leaks ☒ **Debris**

Channel cond debris

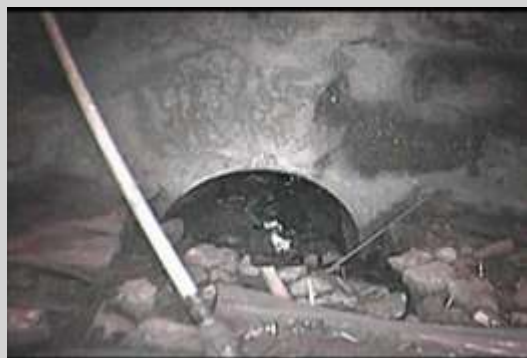
12 O'Clock Outflow

8 in. Circular Gravity Sewer
Pipe Out @ 12 O'Clock

Deposits: ☐ None ☐ Mud ☐ Sludge ☒ **Debris** ☐ Grease

Silt Depth: **5** (in.) Deposits Extent: **Heavy**
